# Manhole Inspection Summary

Manhole # S17K\_\_020MH

Insp Date: **3/6/08 9:37 AM**

**Location** Address: **310 franklin-alley-mchenry**

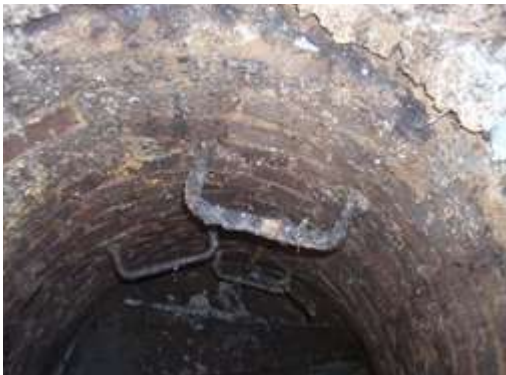
Defect 3

☒ **Evidence Of Surcharge** Depth: **6** (ft.) ☐ Active Surcharge Present

surcharge evidence on the step and wall

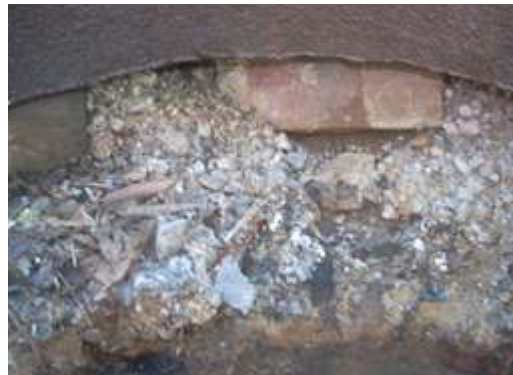
Defect 2

Condition: ☐ Sound ☐ Cracked ☐ Root Intrusion ☐ Loose Brick ☒ **Deteriorated**

deteriorated chimney

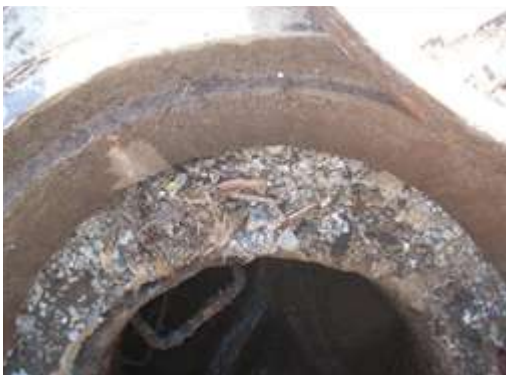
Defect 1

Offset: **6** (in.)

frame offset
